No. 1573

FLIGHT MEASUREMENTS OF THE FLYING QUALITIES OF
FIVE LIGHT AIRPLANES

By Paul A. Hunter

Langley Memorial Aeronautical Laboratory
Langley Field, Va.

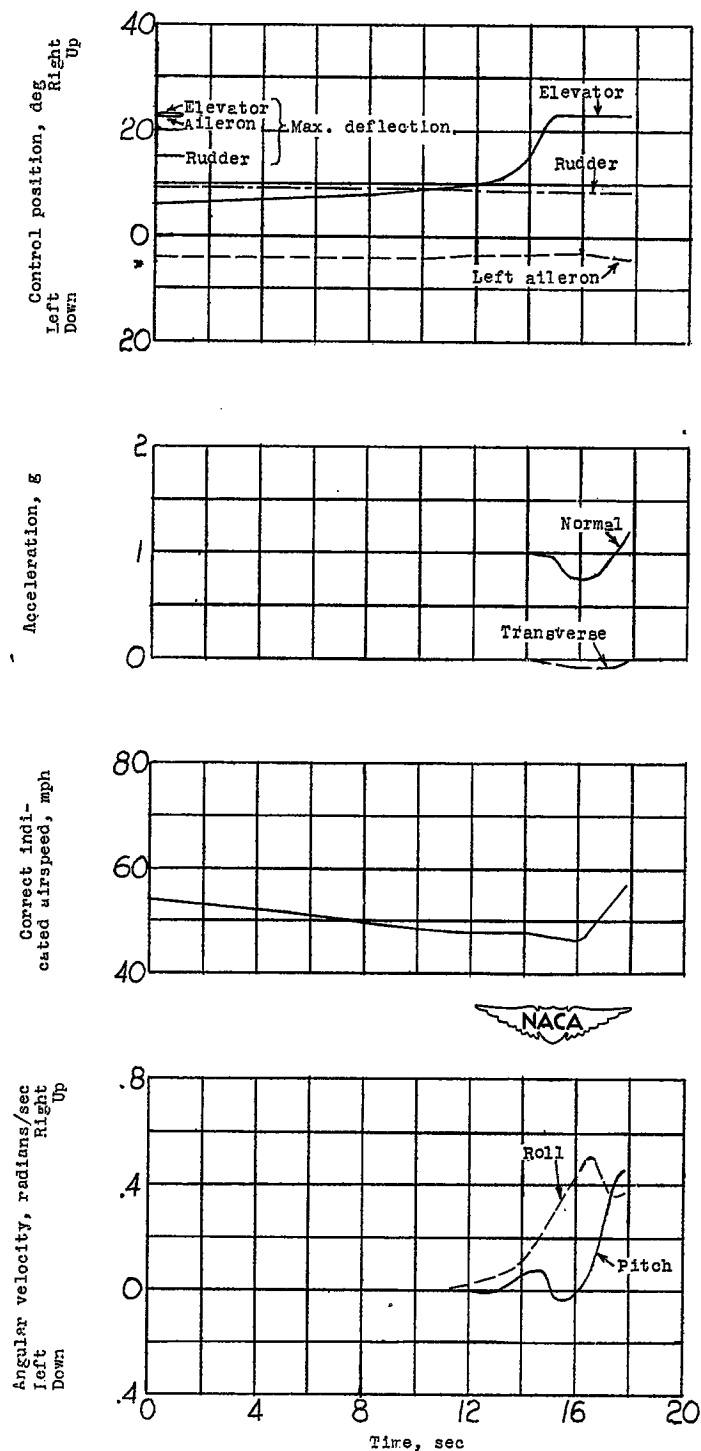
Figure 27.- Power-on stall approach from straight laterally level flight, landing gear up. Elevators were pulled up to their maximum deflection, at which point the resulting unstable motions occurred more abruptly and with somewhat more violence than with elevator held at position for slowly produced stall. Airplane 2.

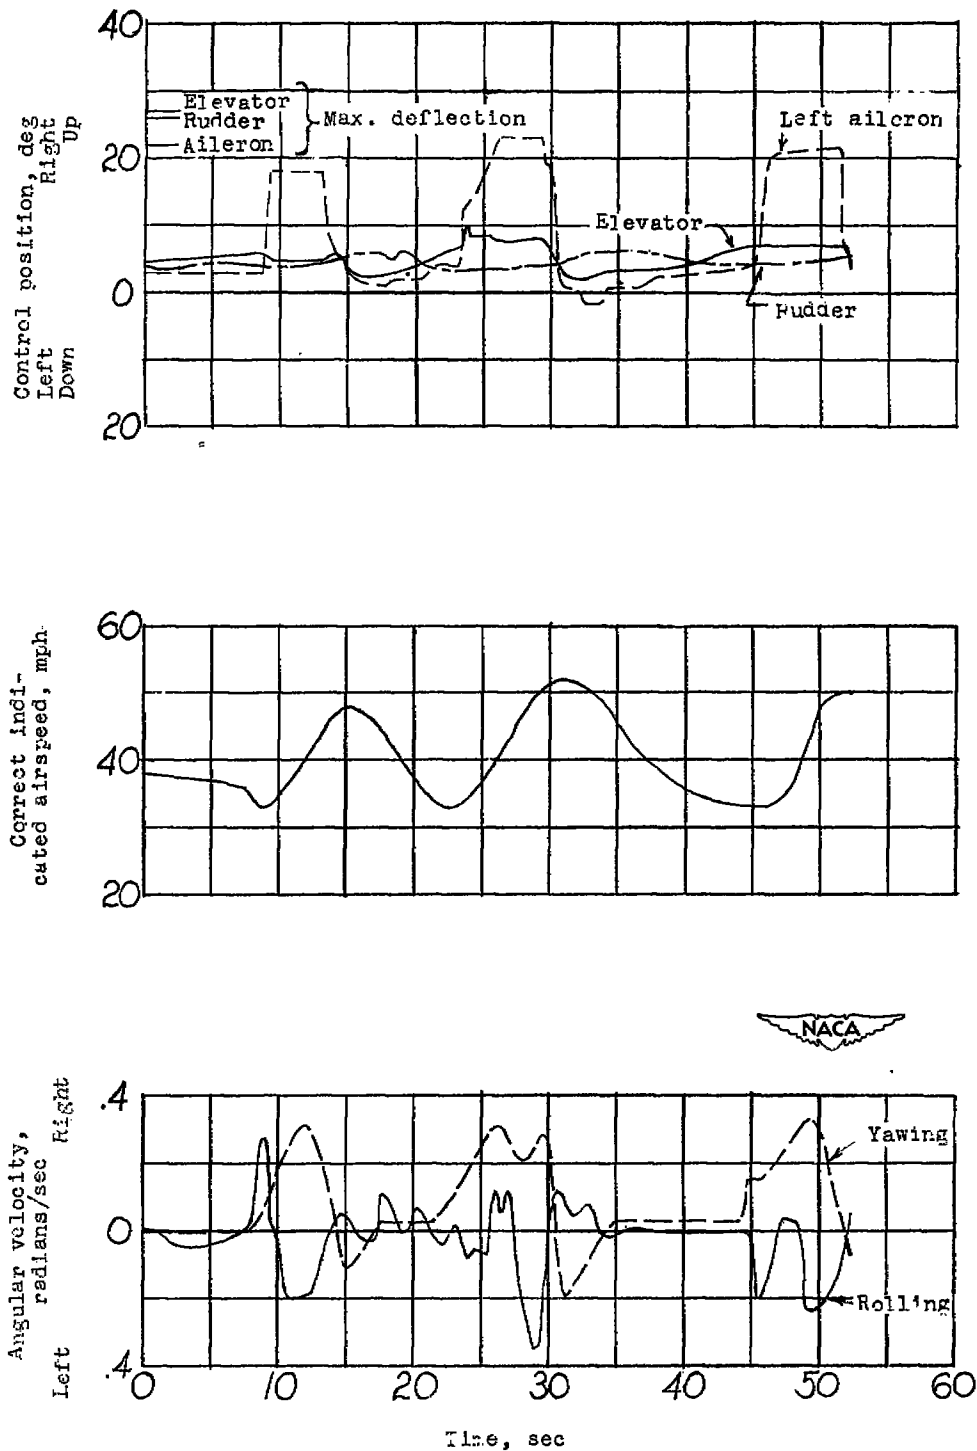
Figure 28.- Power-on stall approach. Elevators moved back until first indication of instability appeared, at which point the ailerons were used. Note the initial correct response in roll followed by a reversal of aileron effectiveness as the effect of adverse yaw predominated. Airplane 5.

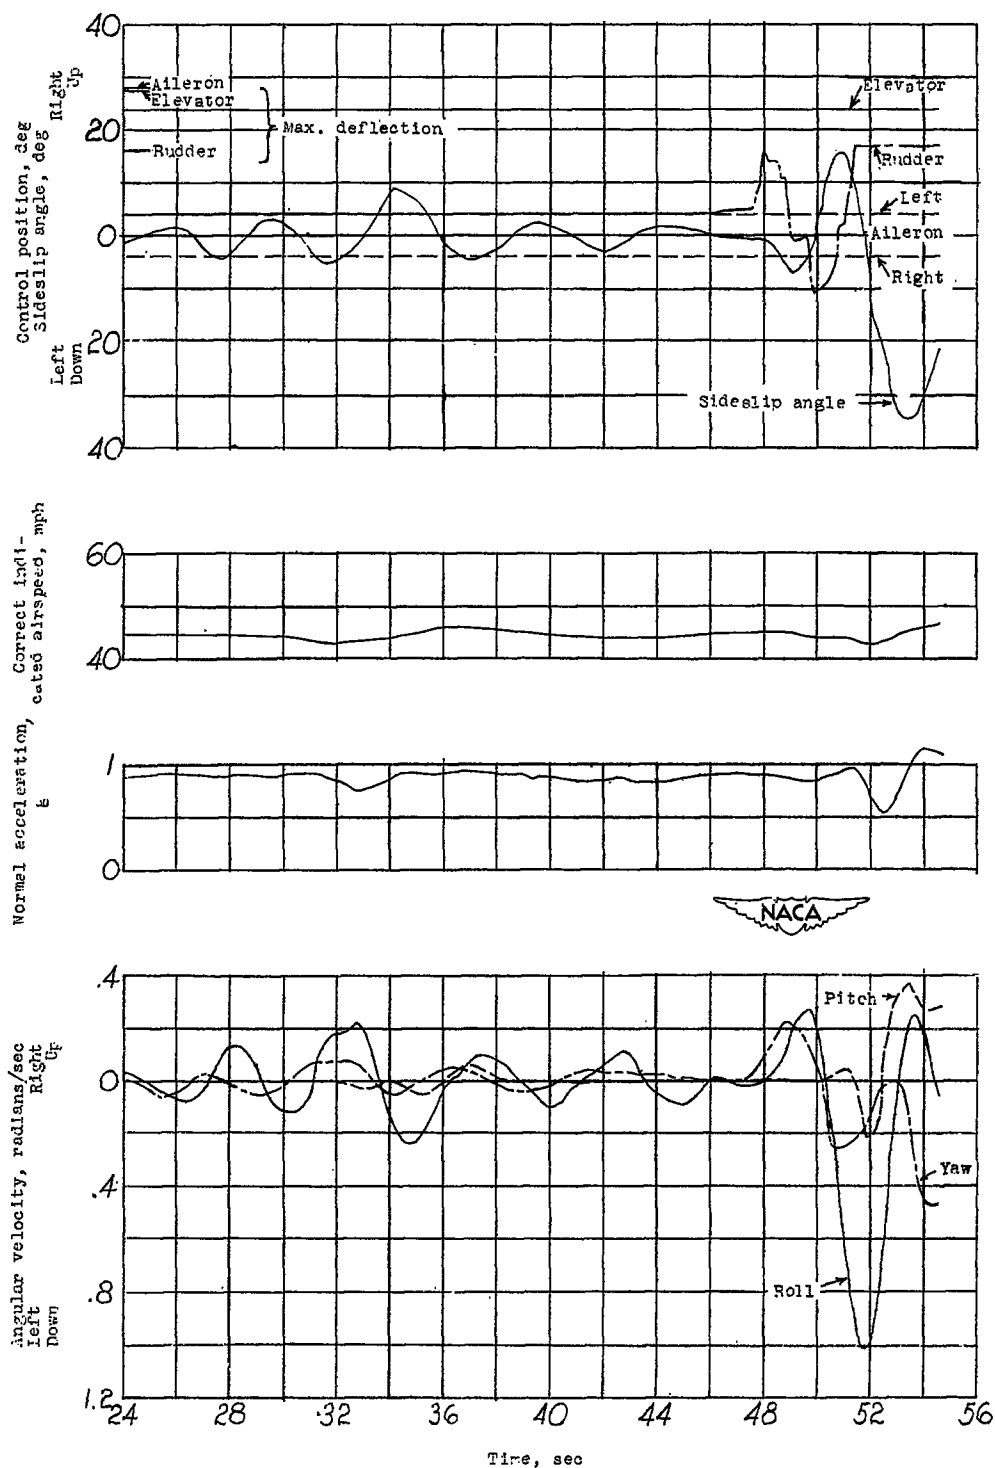
Figure 29.- Response to rudder with stick all the way back. Note continuous oscillation in pitch, roll, and yaw. Also note loss of control following use of rudder. Flaps up; power on; airplane 4.

by reversal of effectiveness as adverse yaw predominated. The response to the rudder with the stick all the way back in the stall is shown for airplane 4 in the flaps-up power-on condition in figure 29.

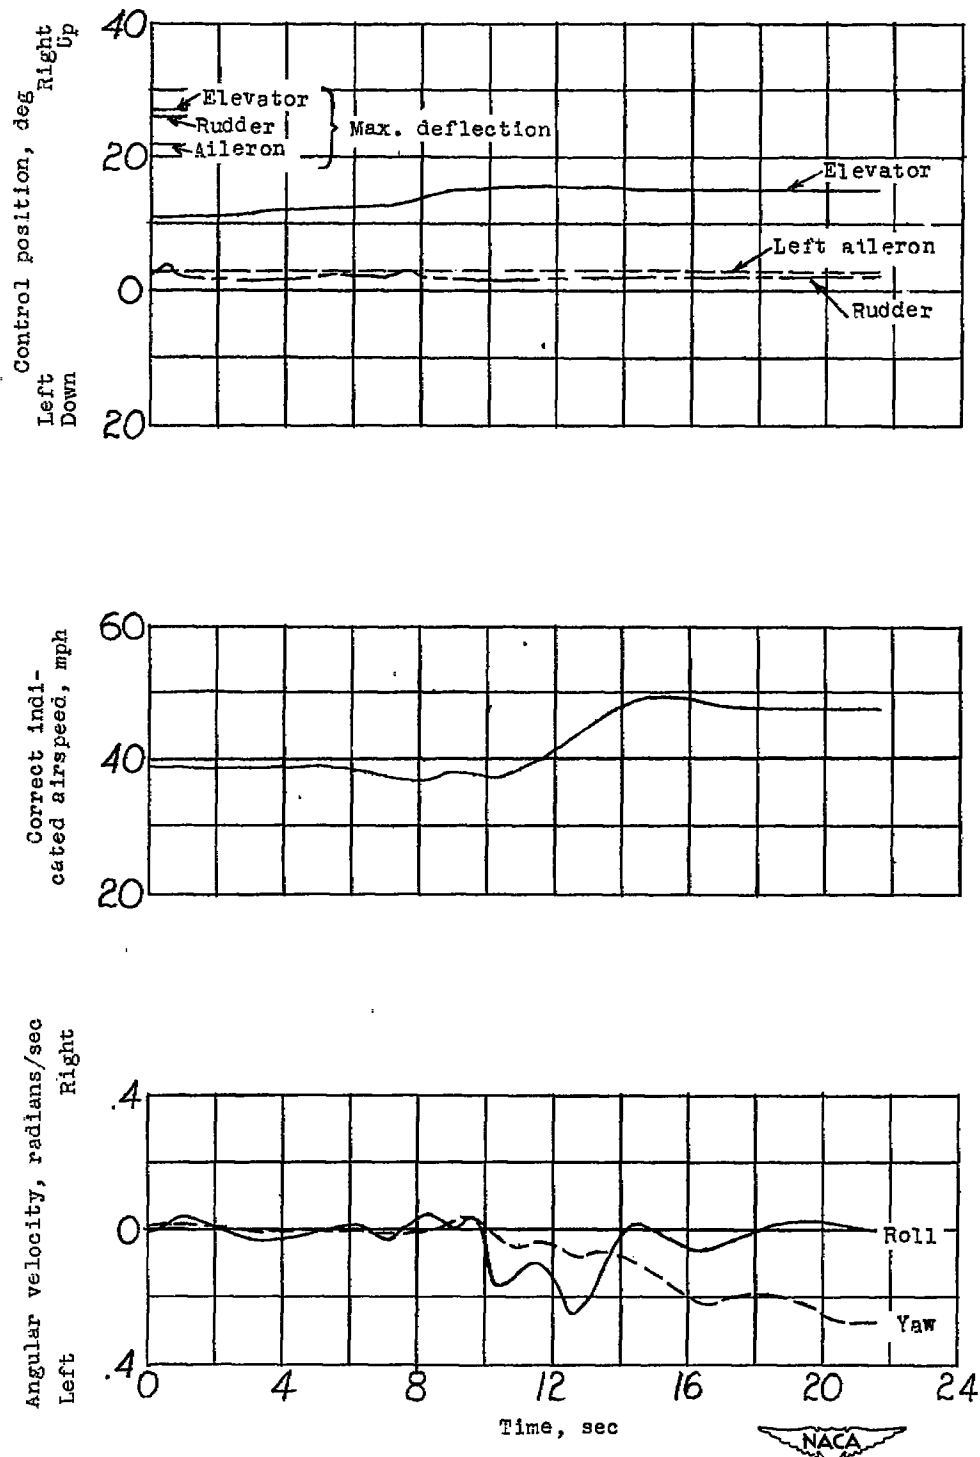
Figure 30.- Power-off stall approach from straight laterally level flight. Elevators were moved back until first indication of instability appeared, at which point all controls were held fixed. Note mild left roll not initiated by pilot which checked itself but resulted in a steady left turn. Airplane 5.

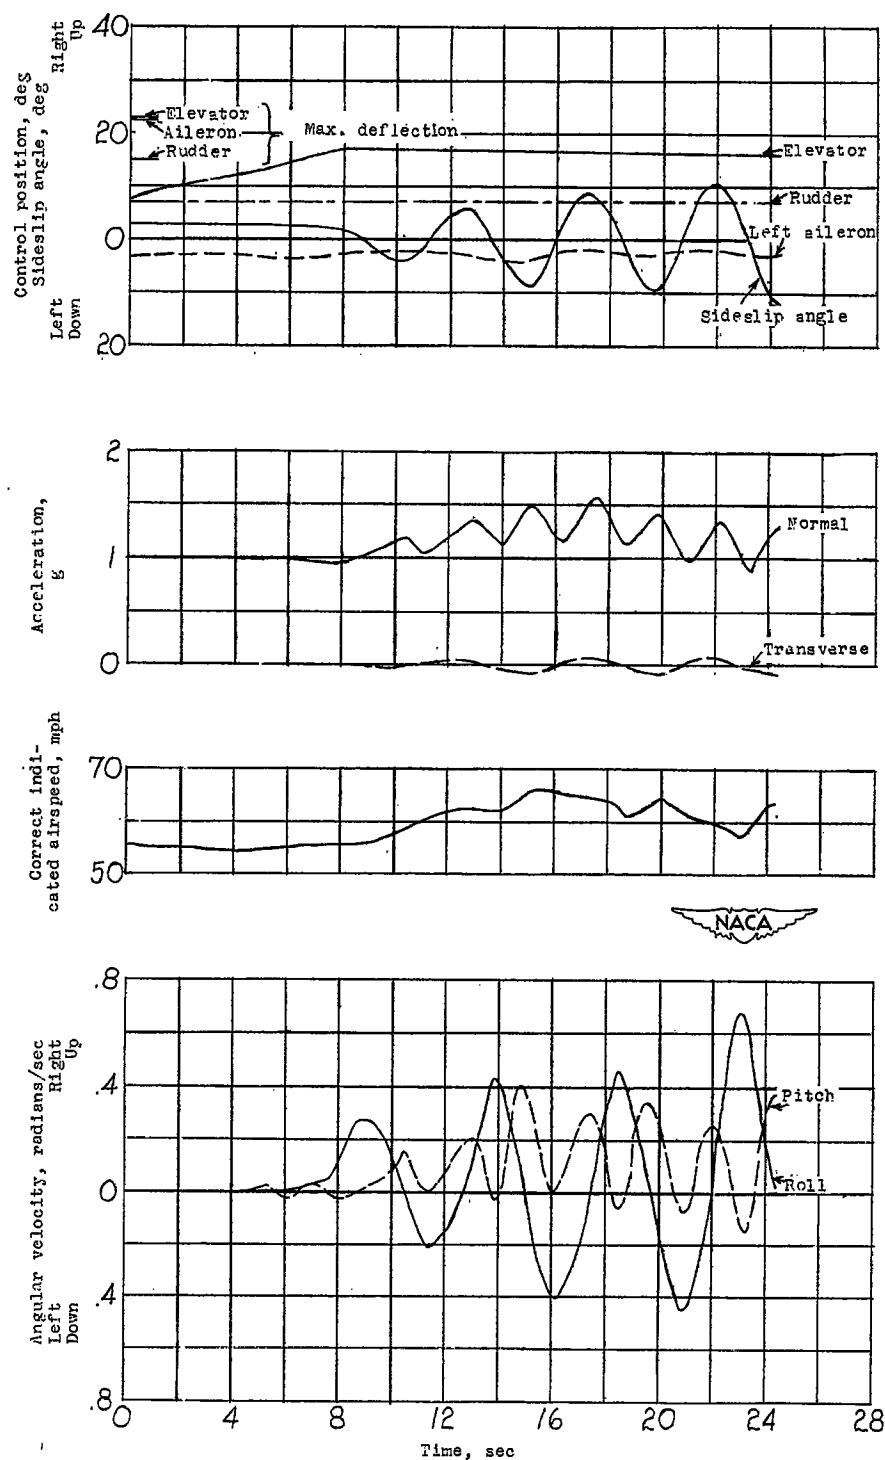
Figure 31.- Power-off stall from straight laterally level flight. When the elevators had been pulled back $3/4$ of full deflection, the other controls remaining essentially fixed, the ship developed a falling-leaf motion with increasing oscillations in roll and pitch. Note also the divergent oscillation in yaw as shown by the variation of angle of sideslip with time. Landing gear up; rearward center-of-gravity position; airplane 2.

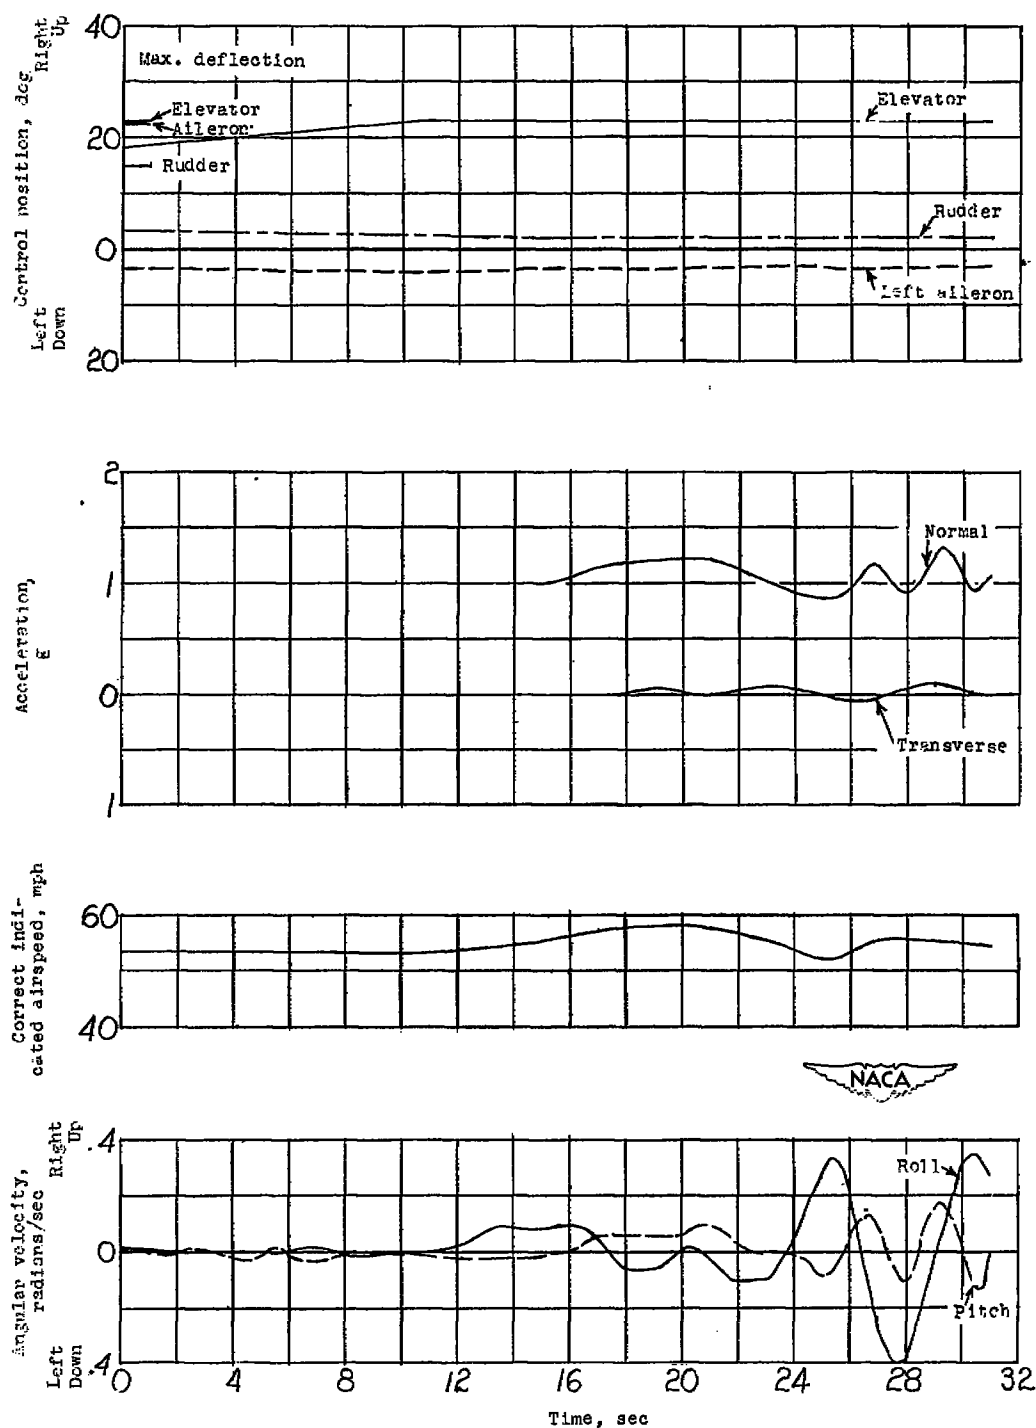
Figure 32.- Power-off stall approach from straight laterally level flight. Elevators were pulled up to their maximum deflections, rudder and ailerons remaining fixed. Note the motions in roll and pitch not initiated by the pilot which slowly increased in magnitude after the elevator had been fully deflected. Landing gear up; forward center-of-gravity position; airplane 2.

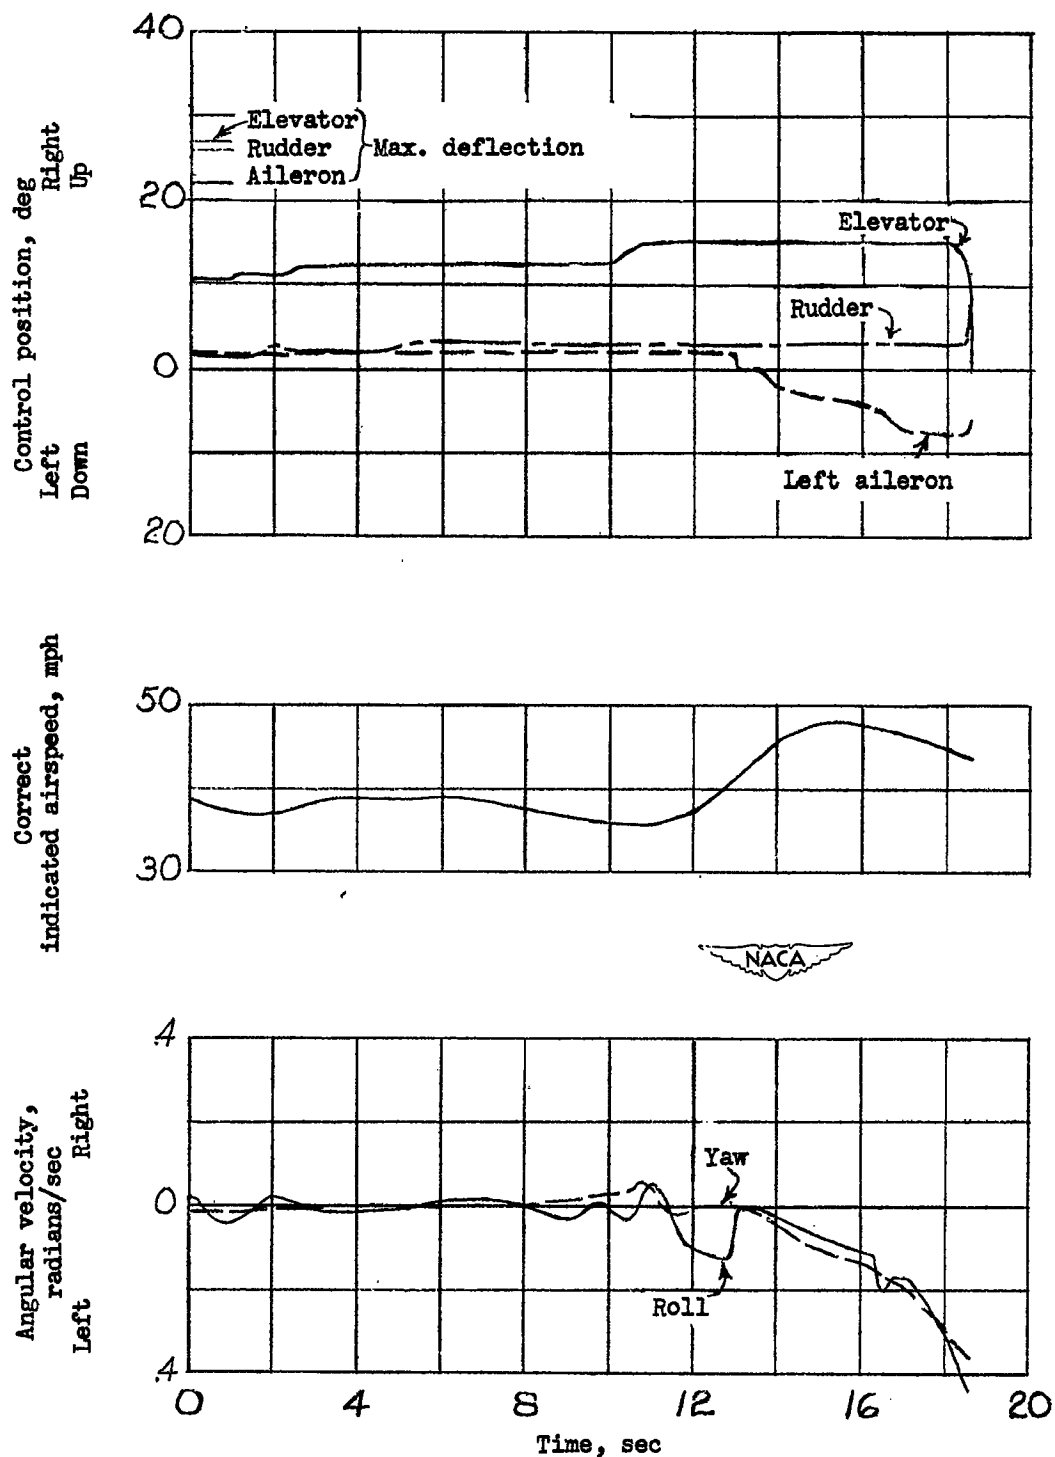
Figure 33.- Power-off stall approach. Elevator moved back until first indication of instability appeared, at which point the ailerons were used. The airplane rolled and yawed left against the applied aileron deflection. Airplane 5.

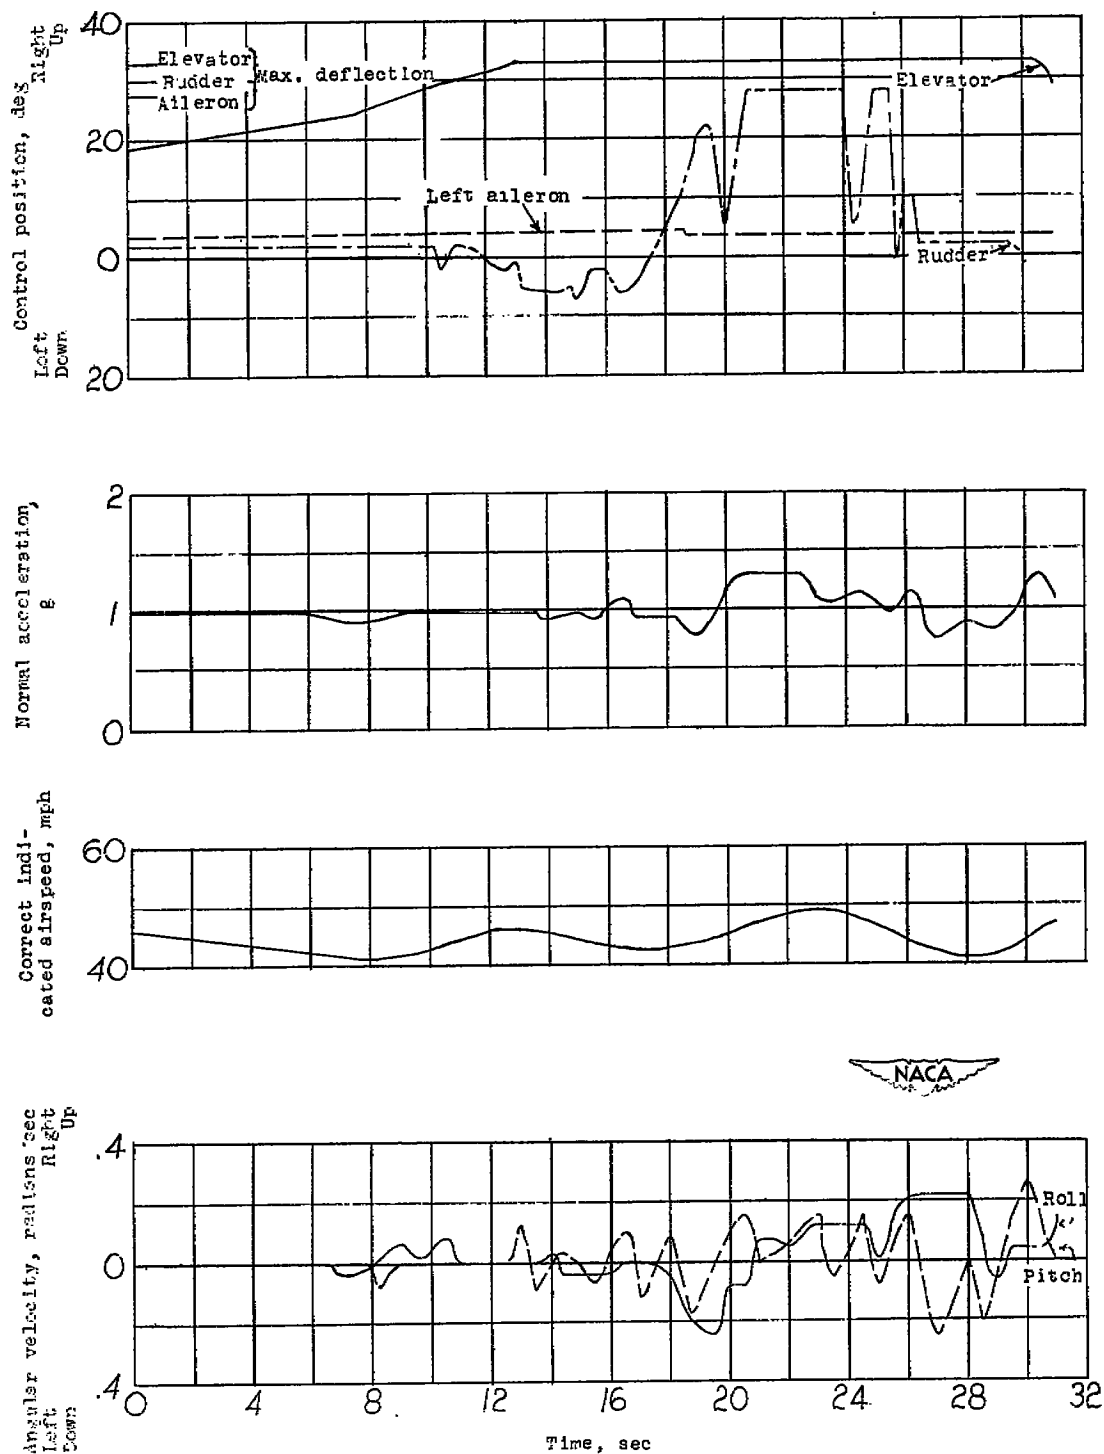
Figure 34.- Flight beyond the stall, power off, using rudder only. Note that pilot can keep violent rolling motion from developing by manipulation of the rudder with the stick all the way back. Airplane 1.

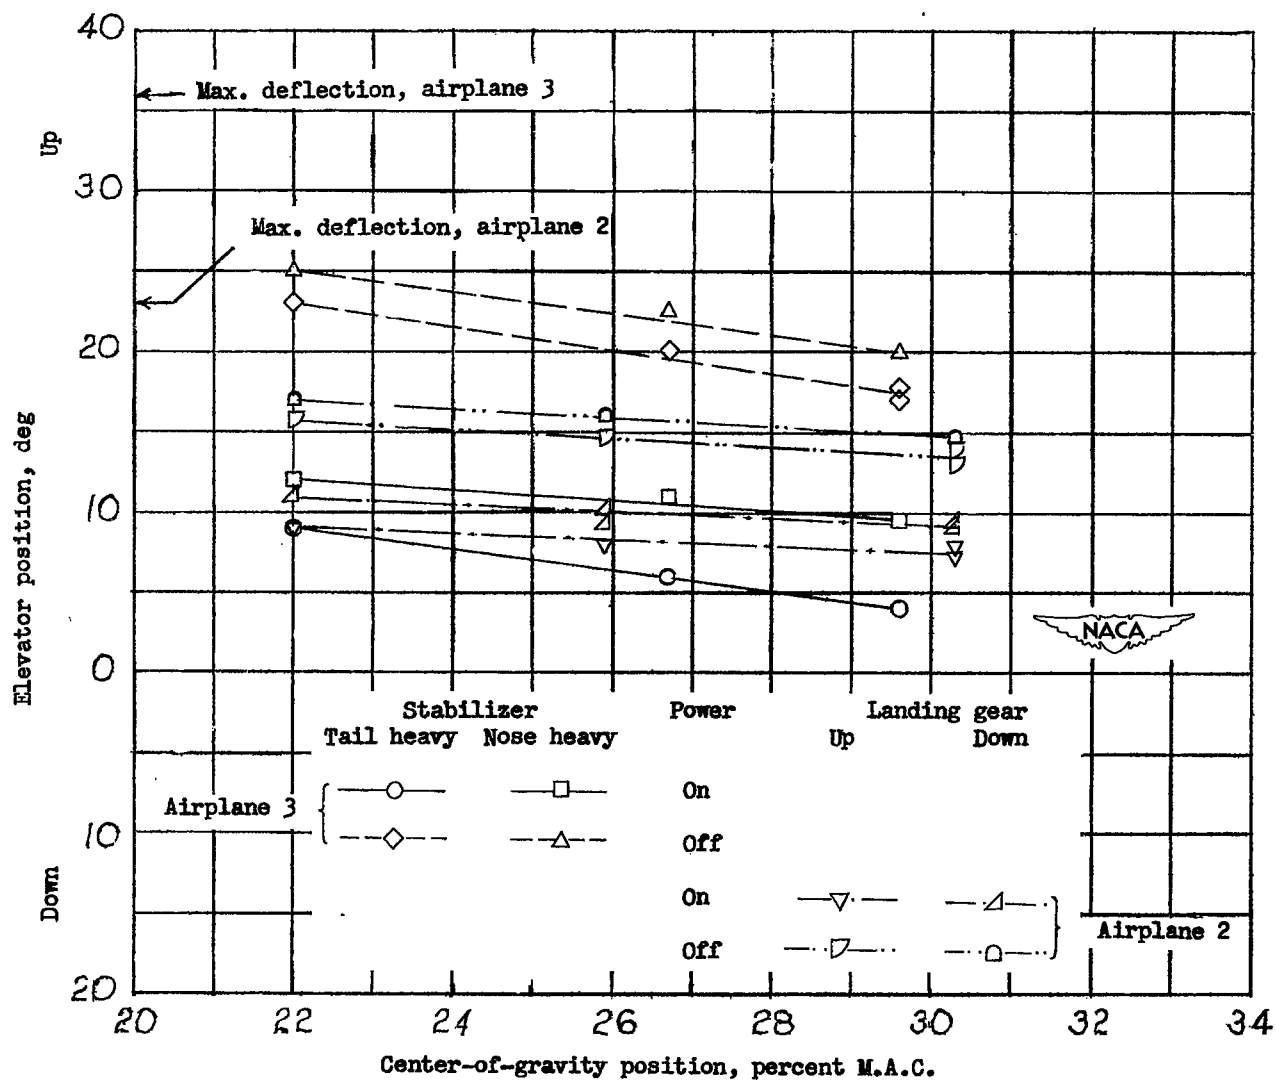
Figure 35.- Elevator positions required to stall at various center-of-gravity positions for different flight configurations. Elevator position measured from thrust axis; airplanes 2 and 3.

The effect of power on the elevator angle required to stall at different center-of-gravity positions is shown in figure 35 for airplanes 2 and 3. Airplane 2 showed the least effect of power on the elevator angles at which motions not initiated by the pilot first occurred, and airplane 3 showed the most effect of power of all the airplanes tested. The difference between elevator angles for the power-on and power-off conditions was of the order of 6° for airplane 2 and 13° for airplane 3 as shown in figure 35. Figure 35 also shows the effect of longitudinal trim for airplane 3 and landing-gear position for airplane 2.

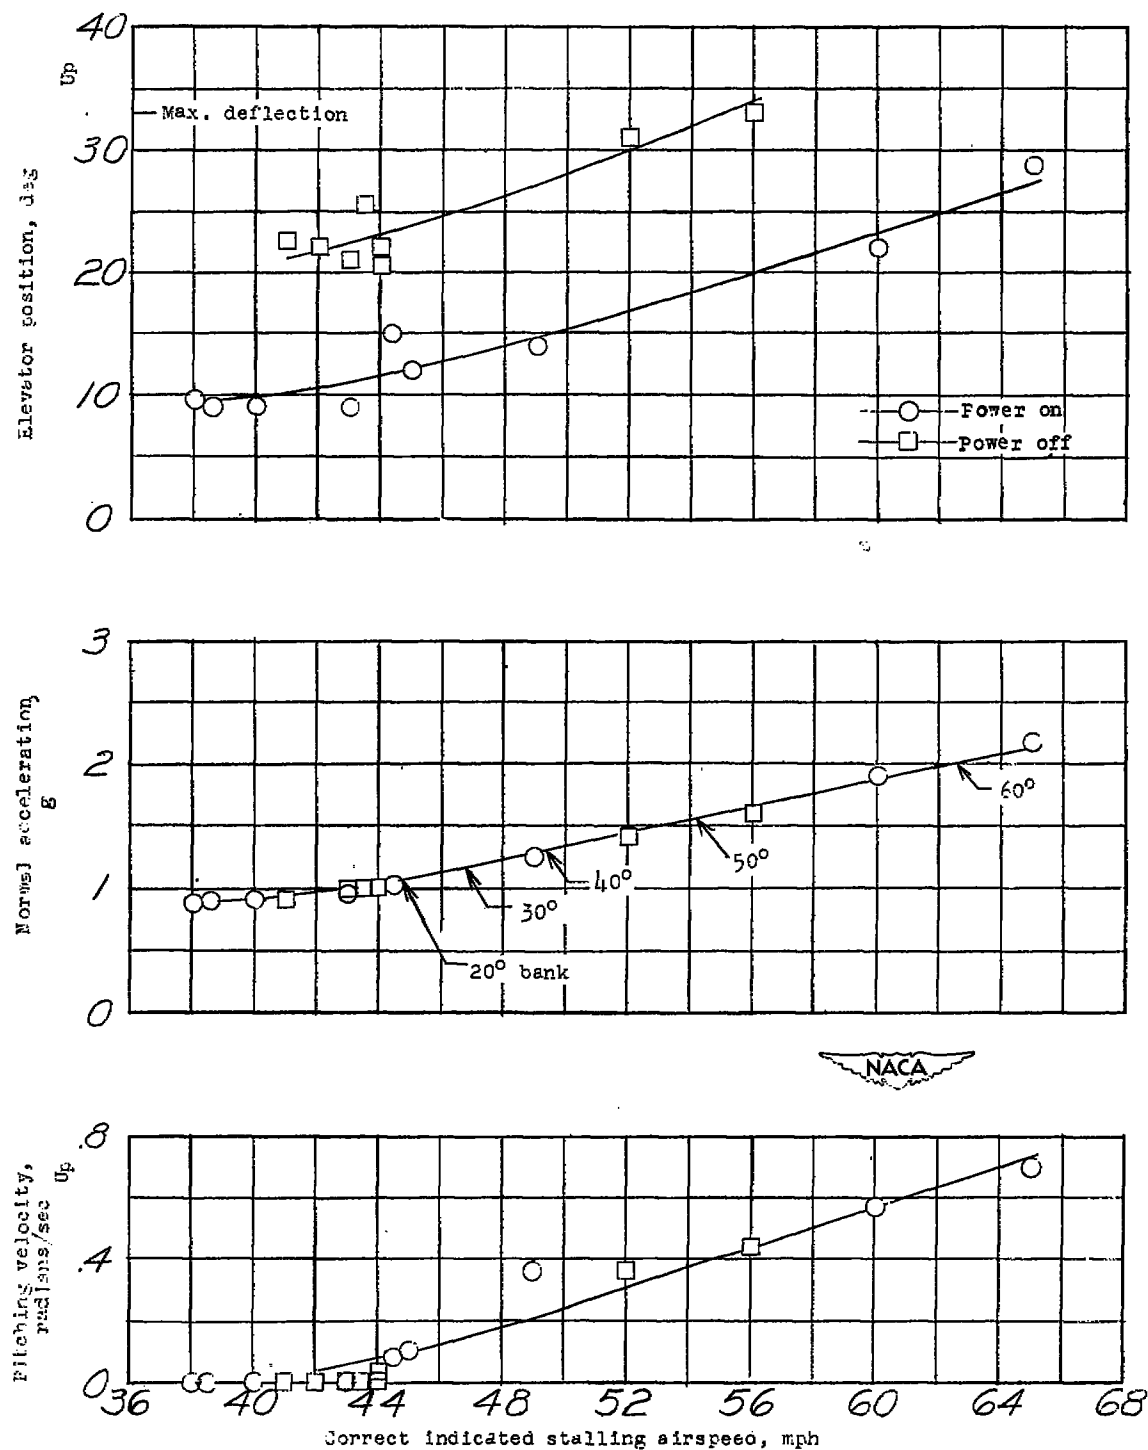
Figure 36.- Variation of elevator position, normal acceleration, and pitching velocity with indicated stalling airspeed in normal banked turns, power on and power off. Elevator position measured from thrust axis; airplane 1.

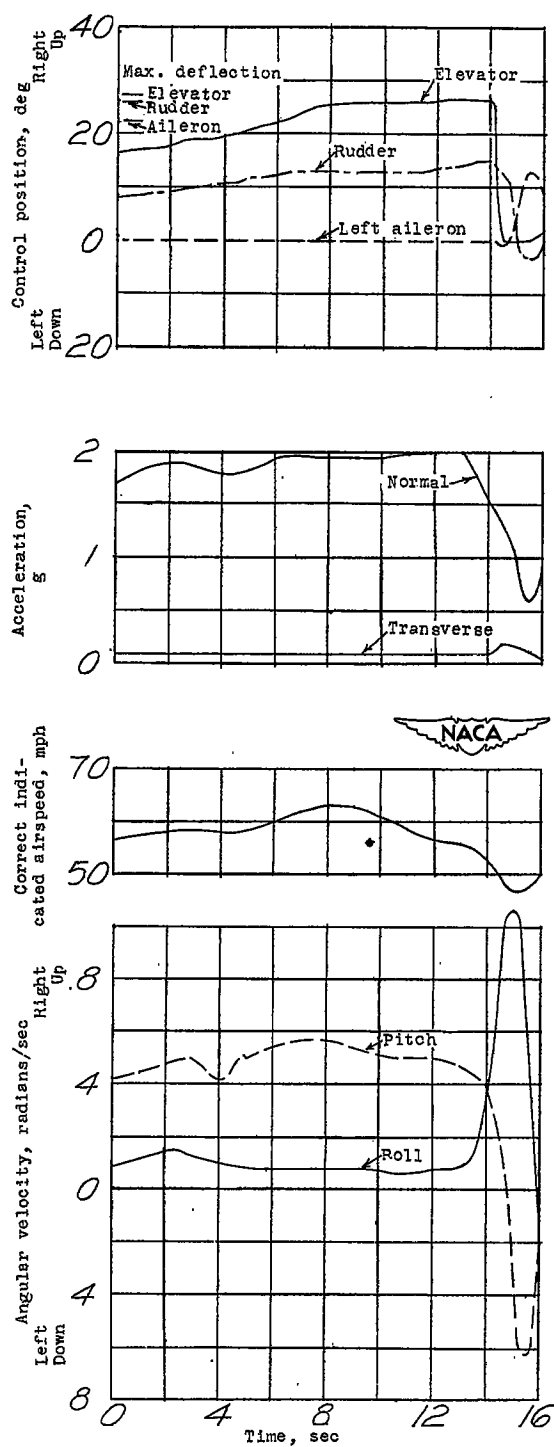
Figure 37.- Stall from a tight power-on left turn. Slipping into turn (as indicated by transverse acceleration) produced roll out of turn when instability occurred. The instability was relieved by moving the elevators down. Airplane 5.

A time history of a stall from a tight power-on left turn is shown in figure 37 for airplane 5. This figure shows that the airplane rolled out of the left turn when sideslip was carried. A power-on right turn in which the airplane again rolled out of the turn when sideslip was carried is shown in figure 38 for airplane 3. This characteristic was also quite typical of airplanes 1 and 5 in this condition. The initial roll-off was found to be either into or out of the turn, the direction depending on whether the airplane carried skid or sideslip, respectively. All the turns in airplanes 1 and 3 carried sideslip, as indicated by the transverse acceleration (plotted positive for acceleration to the left), and the downwind wing stalled first in every case so that the direction of initial roll-off was always out of the turn. When neither sideslipping nor skidding was present, airplane 5 tended, in most cases, to roll into the turn when instability occurred. Instability in this direction is considered a particularly dangerous condition because of the resulting attitude which makes recovery an acrobatic maneuver requiring considerable altitude.

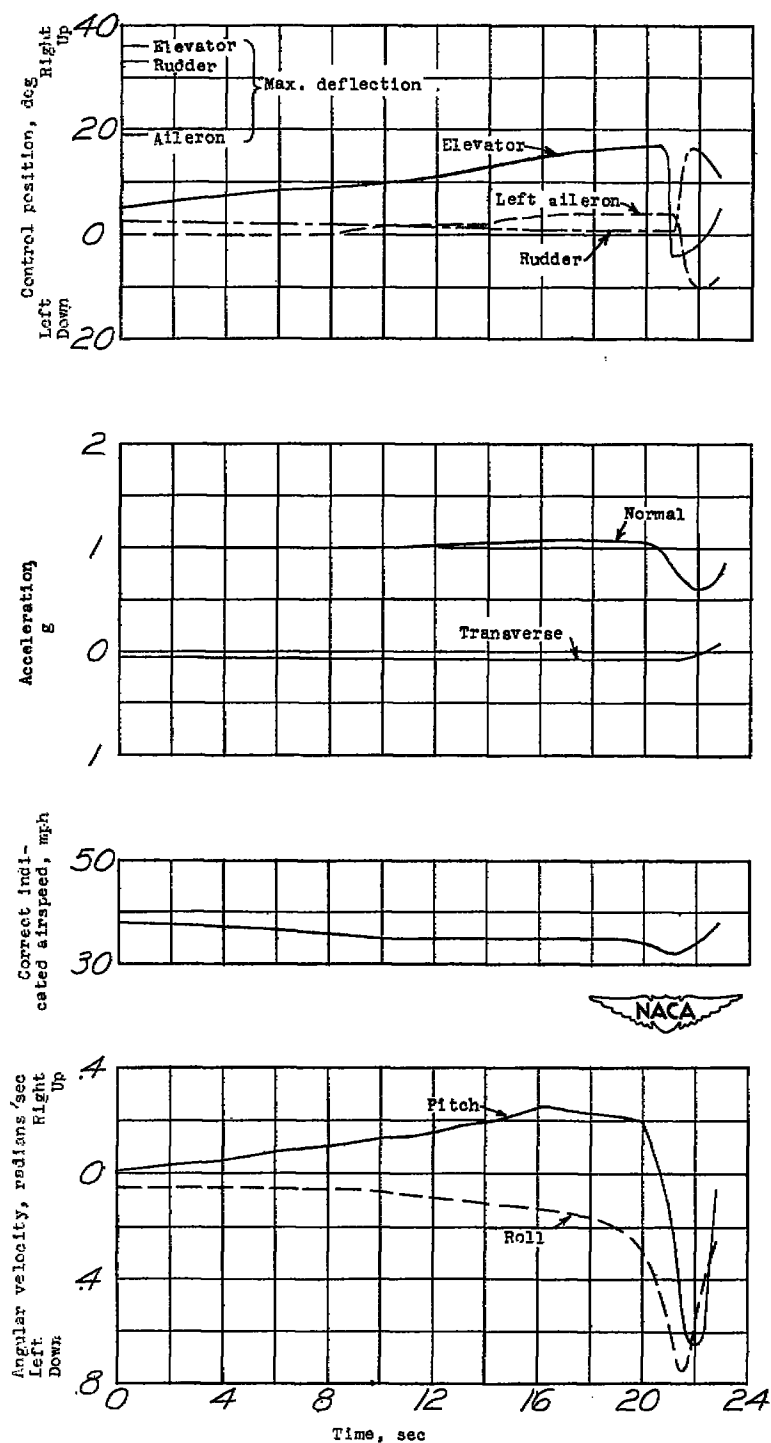
Figure 38.- Stall from a power-on right turn. Note that aileron was held out of the turn and sideslip occurred into the turn. Elevators were slowly pulled up, lateral instability developing at about 16 seconds and resulting in a roll-off out of the turn. Airplane 3.

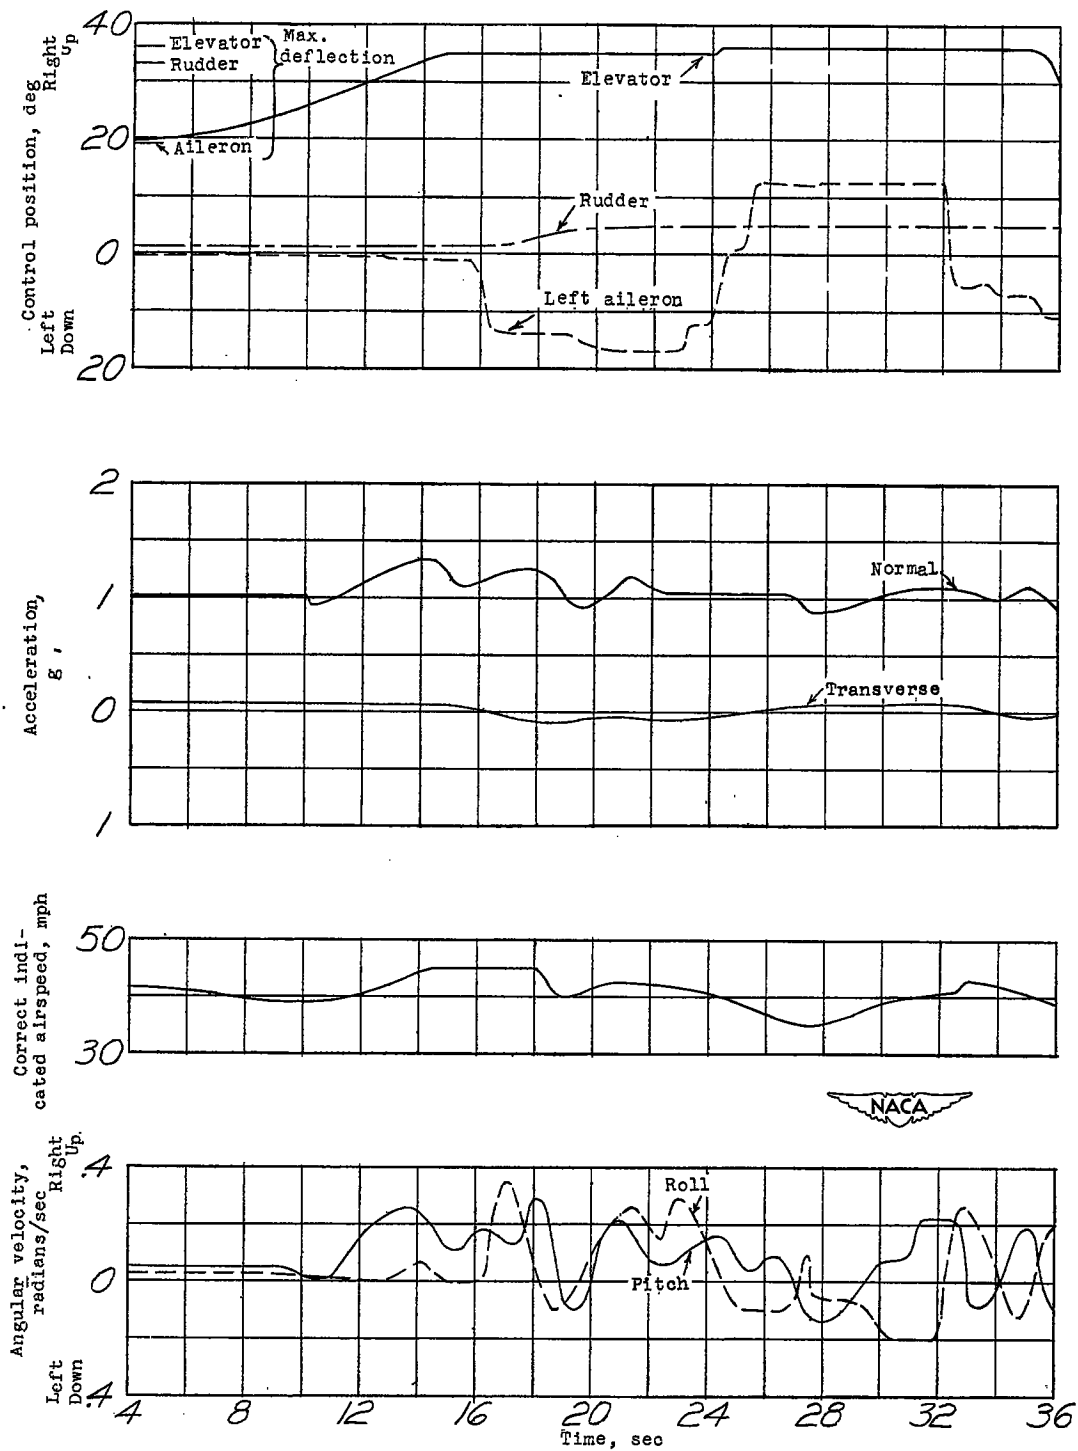
Figure 39.- Attempt to produce power-off stall in left turn. No instability occurs with the elevators full up. Controlled aileron rolls were made to right and left with the elevator remaining fully deflected. Airplane 3.

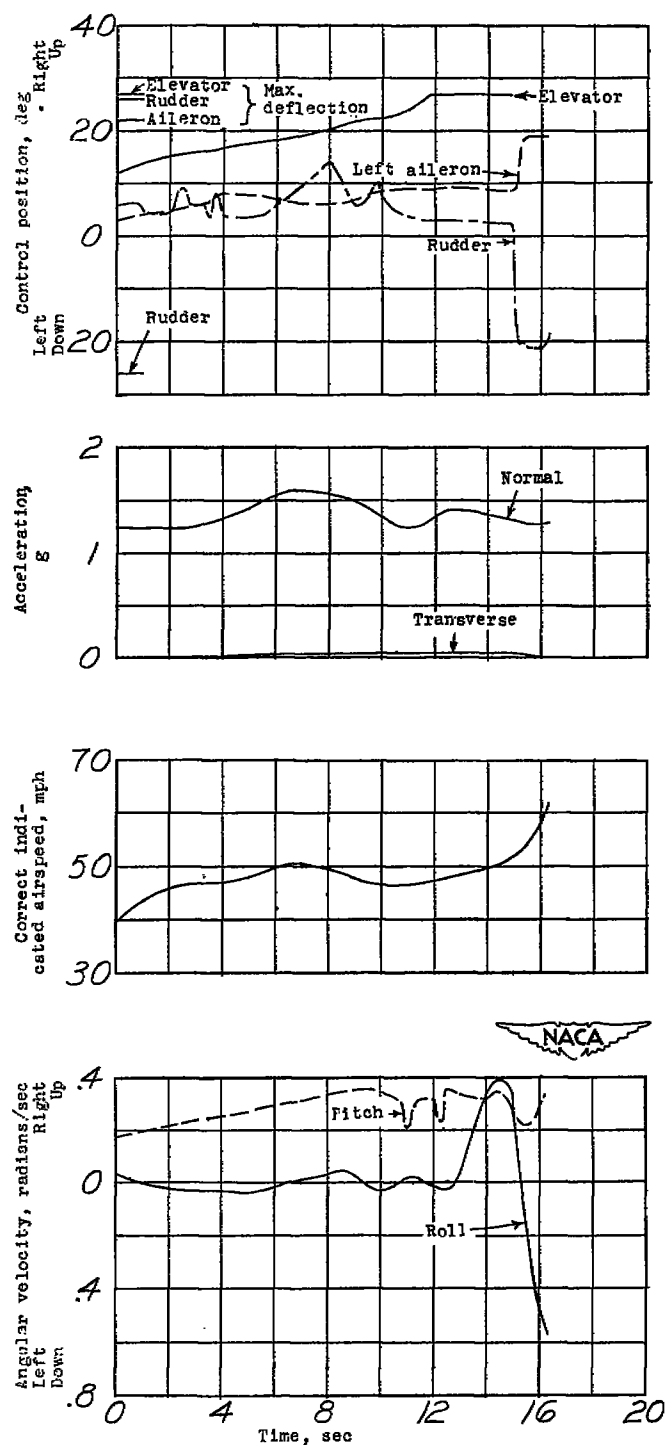
Figure 40.- Stall from a power-off right turn. Transverse acceleration indicates skidding out of turn. As a result, the airplane rolled into turn when instability developed. Note small pitching motions prior to the roll-off which were not initiated by pilot. Airplane 5.

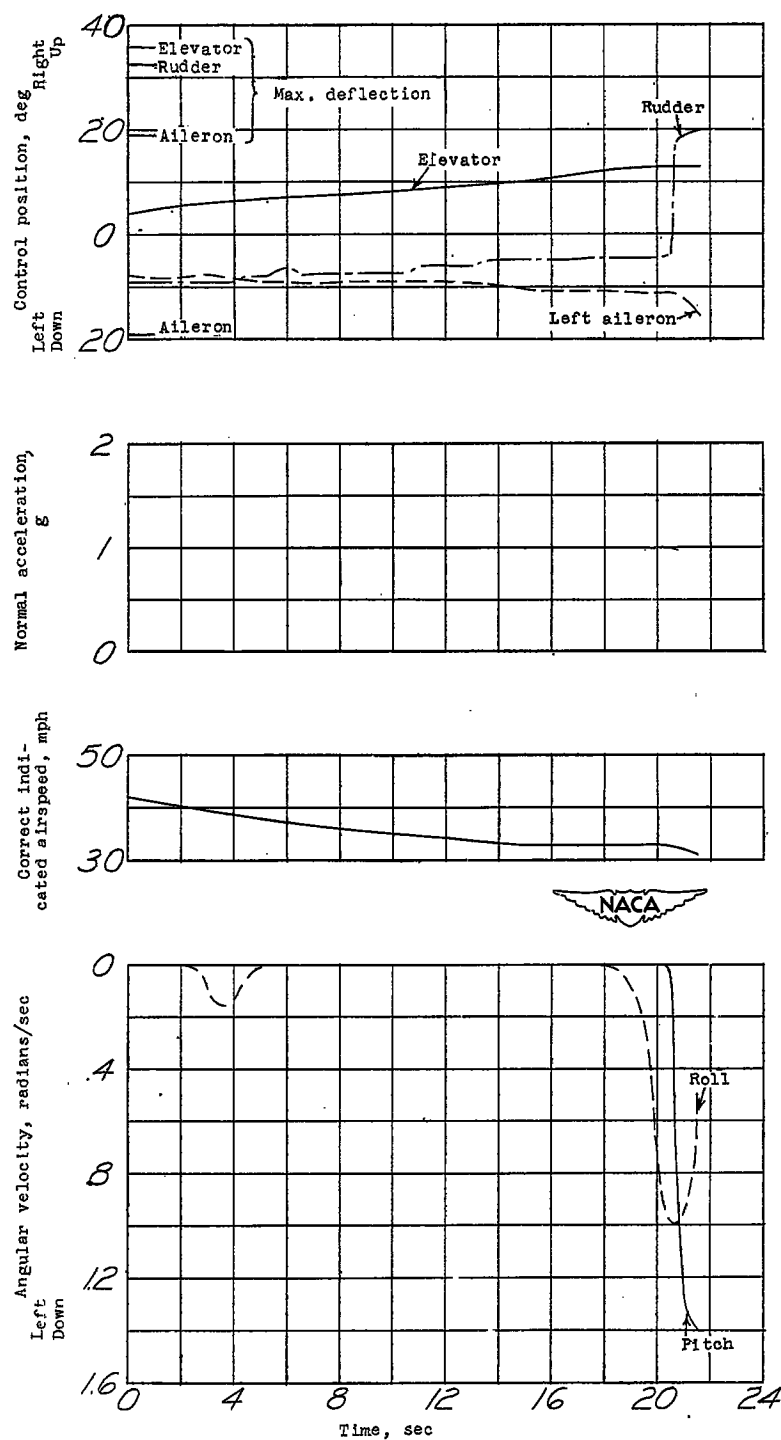
Figure 41.- Stall from a 20° right sideslip with power on. Airplane spun out of sideslip when lateral instability occurred. Note large values of pitching velocity attained. Airplane 3.

Stalls from steady yawed flight.—Stalls from steady yawed flight were produced in airplane 3 to compare the resulting stalling characteristics with those experienced under unyawed conditions with particular regard to studying the effects of carrying sideslip or skid in turning flight. These stalls were executed by the usual gradual reduction in airspeed, but the rudder and ailerons were manipulated to maintain a steady yawed condition. The direction of roll-off and the violence of the resulting instability were studied. The results are presented in the form of time histories in figures 41 to 43.

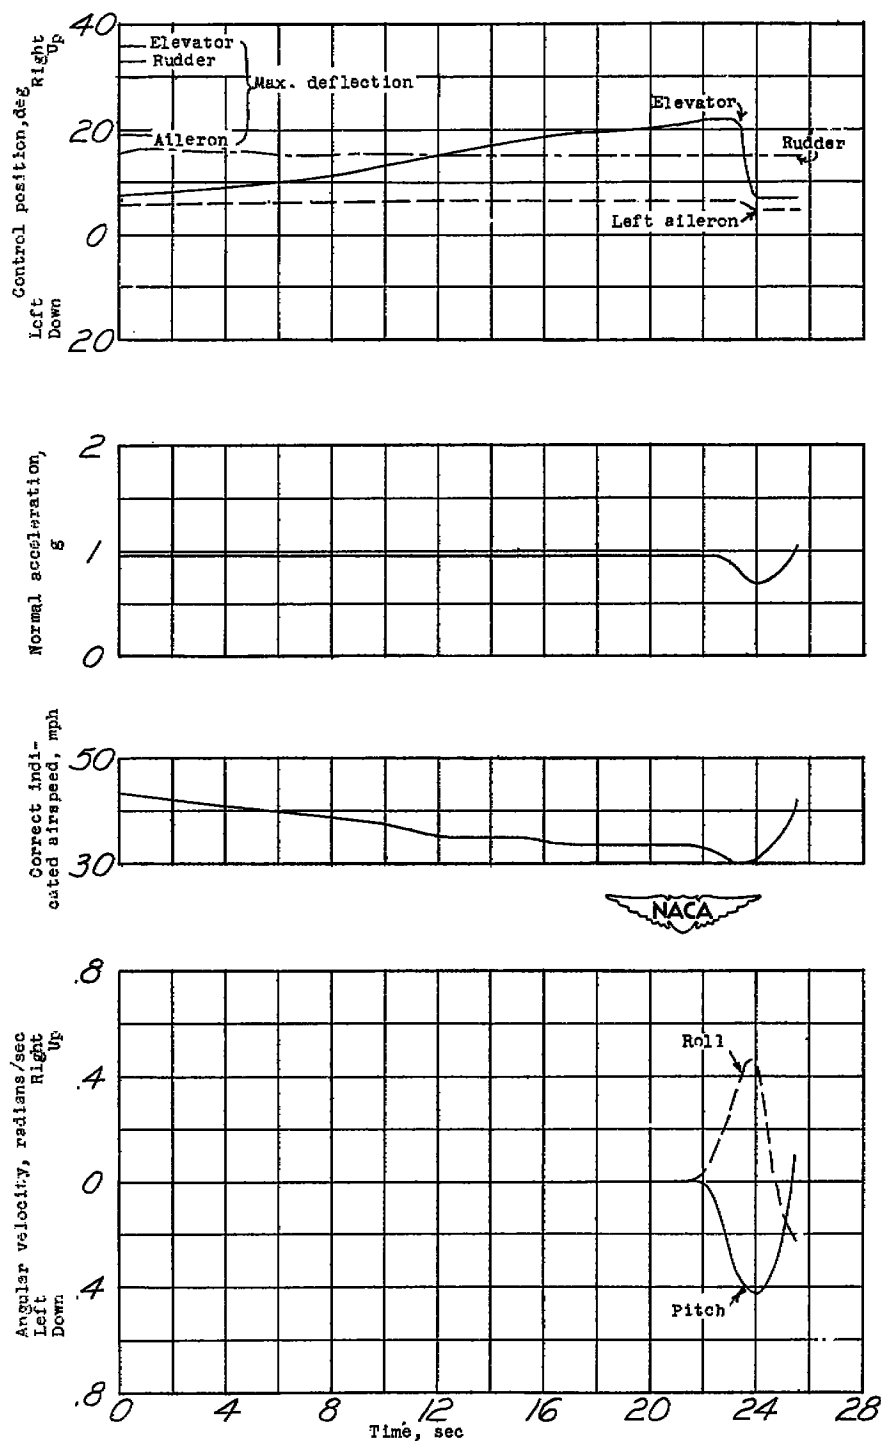
Figure 42.- Stall from a 20° left sideslip with power on. Airplane spun out of sideslip when lateral instability occurred. Instability was checked by pushing the elevators down. Airplane 3.
